# Inactive Mine Site Field Form

**Project:** Animas Forks

**ID:** PG3

**Claim Name:** Virginia Extension

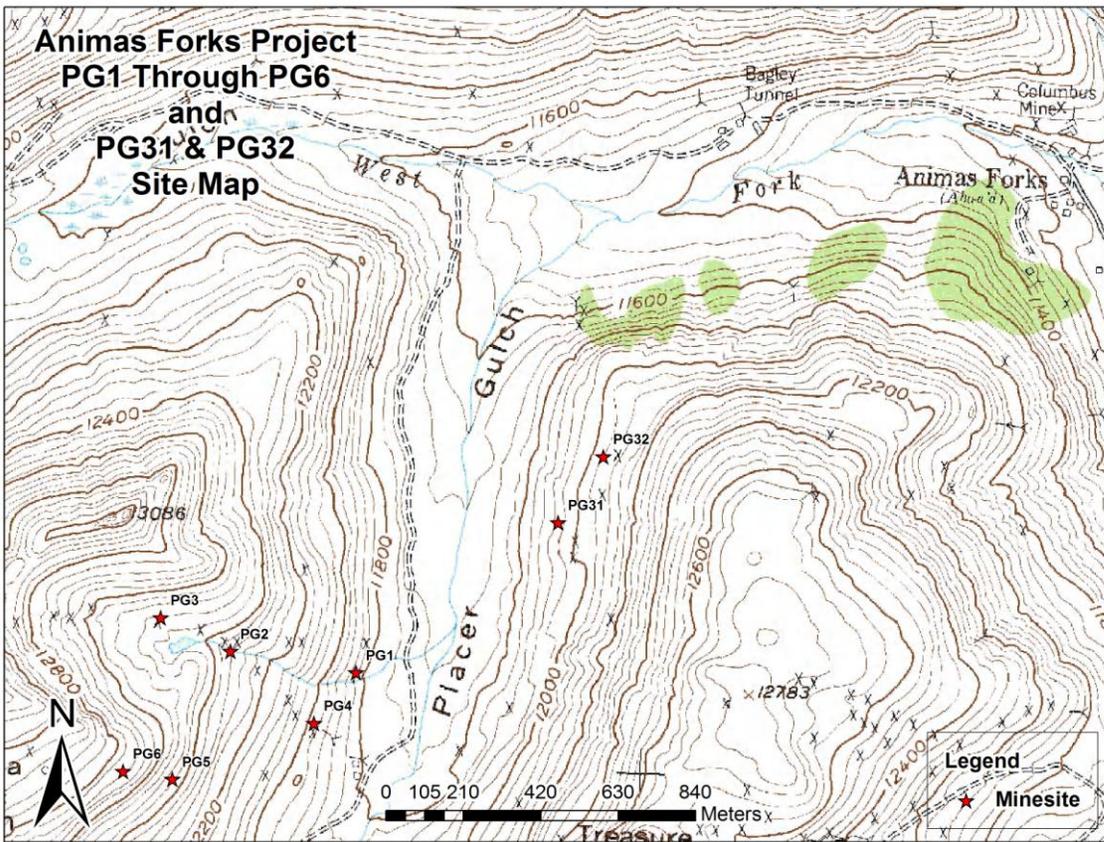
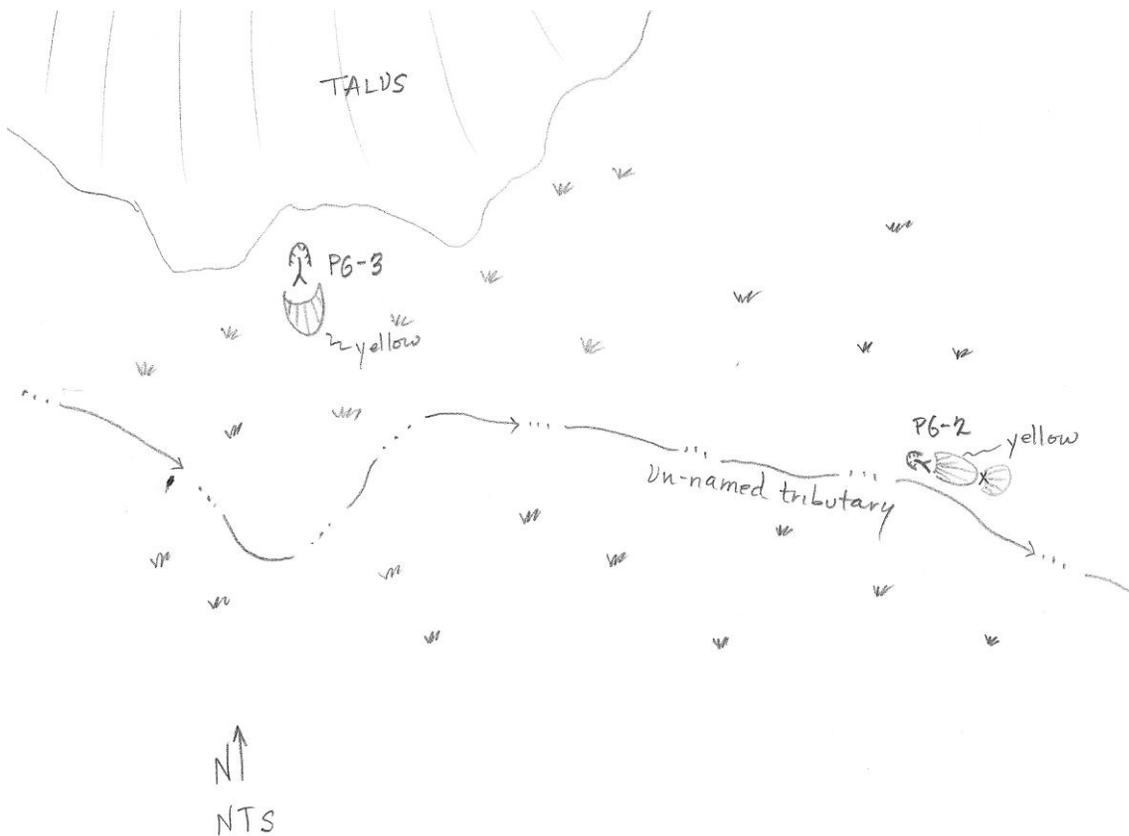
**Field Description:** Up the same un-named drainage as PG2, on the north side of the amphitheater where the talus and vegetation meet. The mine site has a small yellow mine waste pile.

**Type of Feature:** Adit

**Condition:** Intact

**Excavated Dimensions:** 5 x 7

**Drainage w/ flow, ppt, pH, etc:** 12" standing water

**Preferred Closure Method:** Backfill

**Work Description:** Hand Backfill per SWS 2. Not a high priority for closure.
